CLUTCHTECH

TSB-DE01

Clutch Release Mechanism Problems

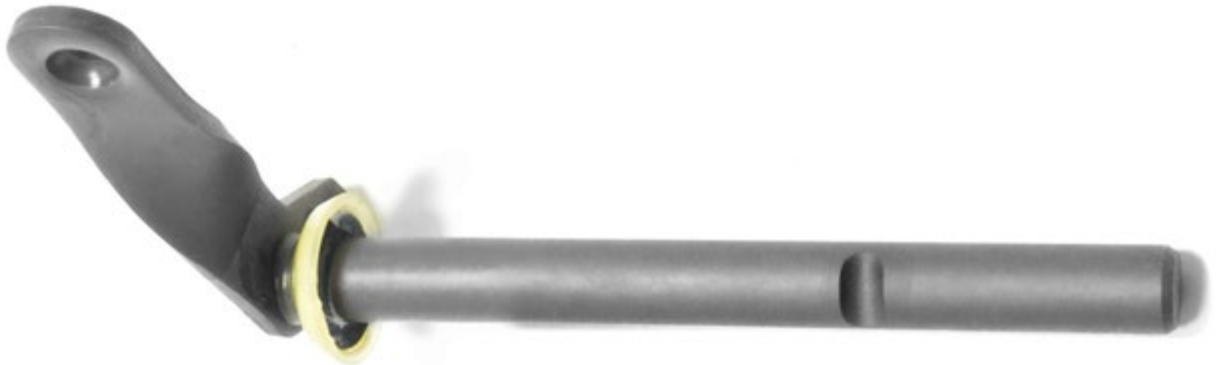
The cross shaft in these vehicles will often experience fractures in the welds between the arm and the cross shaft which causes the slave cylinder to bottom out on the circlip after installation. These fractures cannot be seen but can be identified by inspecting the angle of the arm to the cut out in the cross shaft. If the cross shaft is damaged, as shown below, a new cross shaft must be used in the vehicle. These cross shafts are commonly available from Australian Clutch Services.

Worn/Damaged
