NOISE or SQUEAK coming from BELLHOUSING?

Tips for correctly identifying the cause.

AUSTRALIAN CLUTCH SERVICES *

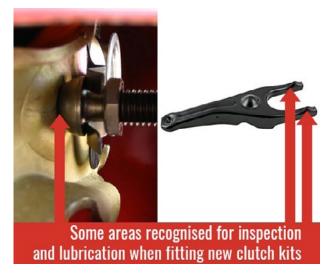
Noises emanating from the bellhousing area after fitting a new clutch are often misdiagnosed as a faulty thrust bearing.

Poorly lubricated Clutch Fork, Pivot Ball, Bearing to Fork contact face or Bearing guide tube (Incorrect release bearing failure diagnosis)

- 1. Remove the gearbox. Inspect all clutch control components Repair or replace if necessary
- 2. Clean & lubricate all moving components in the clutch operation system. ACS recommends SPG3 lubricating grease which is available from your local distributor.
