TSB-FW02

Machining the Flywheel When Fitting a New Clutch

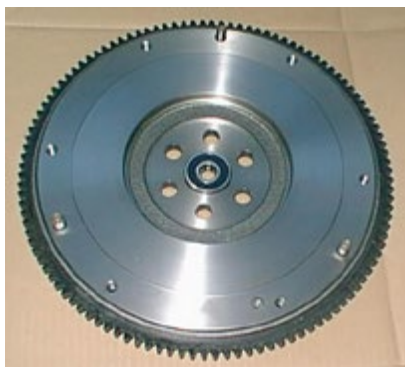
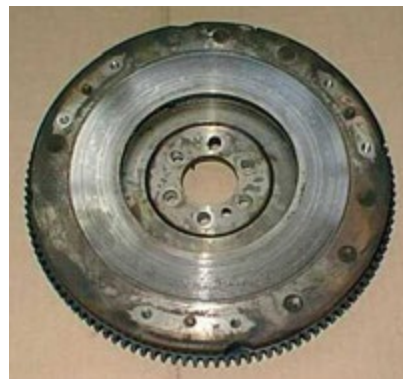
If the flywheel surface is heat-cracked or the flywheel runout exceeds 0.1mm, the flywheel must be replaced, as it is almost impossible to correct these faults by machining. A cracked or distorted flywheel is also a serious safety risk as it could burst while in the vehicle and cause severe injury to the driver and passengers. Flywheel runout must be measured with a dial indicator gauge mounted on the engine as illustrated in the sketch below.

Care must be taken to ensure that the specified flywheel profile is maintained by machining the cover assembly-mounting surface by the same amount as the contact surface. Where the flywheel has a step or recess, this must be machined exactly in accordance with the vehicle manufacturer's specifications in order to prevent clutch non-release and slipping problems.
