CLUTCHTECH

TSB-DE01

Clutch Release Mechanism Problems

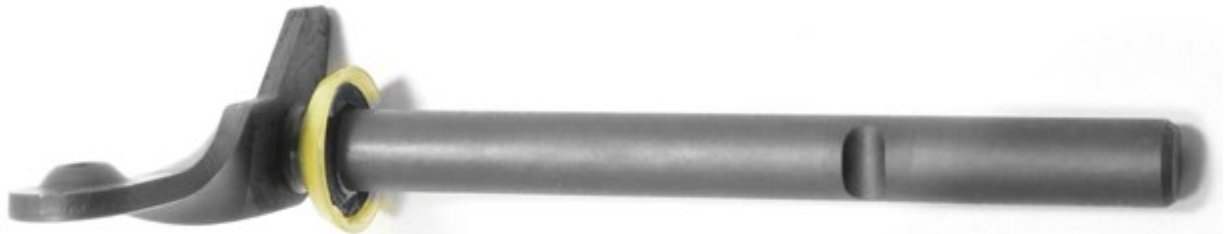
The cross shaft in these vehicles will often experience fractures in the welds between the arm and the cross shaft which causes the slave cylinder to bottom out on the circlip after installation. These fractures cannot be seen but can be identified by inspecting the angle of the arm to the cut out in the cross shaft. If the cross shaft is damaged, as shown below, a new cross shaft must be used in the vehicle. These cross shafts are commonly available from Australian Clutch Services.

New
